Case Study 5: Collision in Foggy Conditions

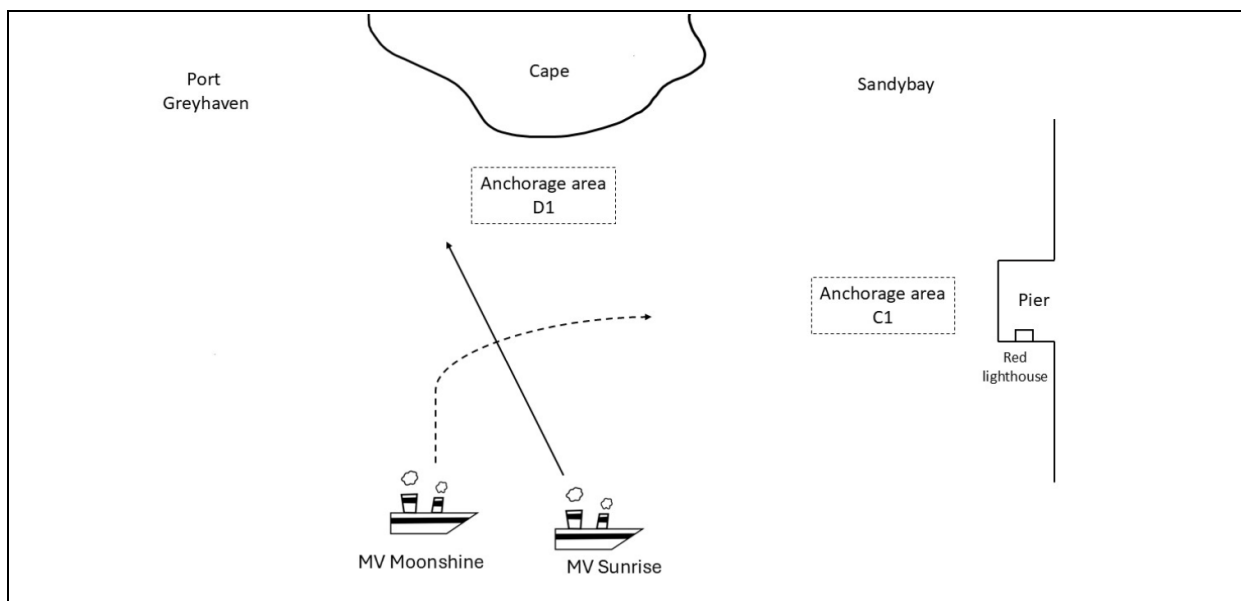
Let us now examine the initial situation. Motor Vessel Sunrise is proceeding north to Port Greyhaven. Motor Vessel Moonshine is proceeding north toward the anchorage area where she is planning to drop anchor. The weather is foggy and visibility reduced. The AIS of Motor Vessel Moonshine is not operational.
